# WROUGHT IRON *for* UNDERGROUND SERVICES

A TECHNICAL BULLETIN PREPARED BY THE ENGINEERING SERVICE DEPARTMENT

**A. M. BYERS COMPANY • PITTSBURGH, PA.**

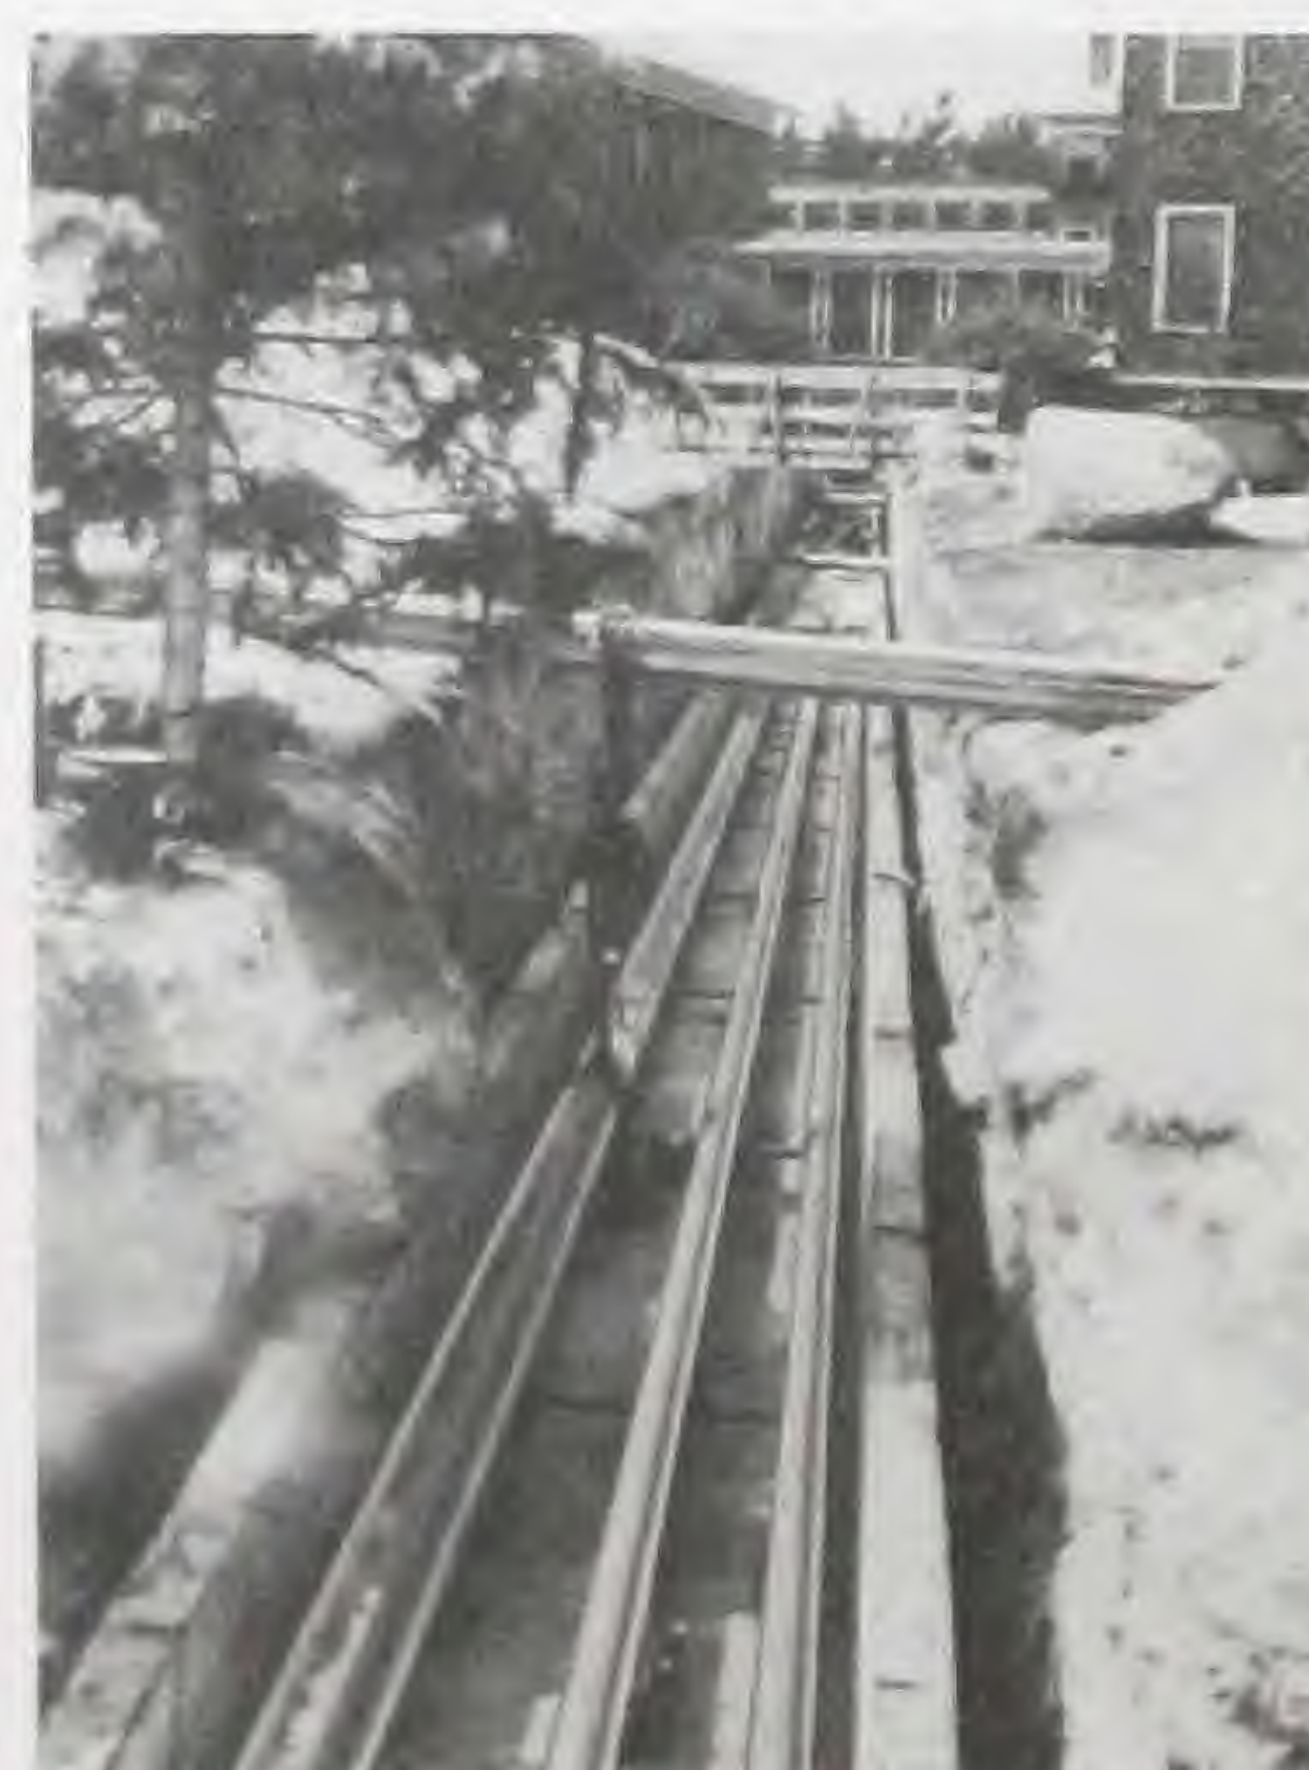
Fig. 52

The State of Rhode Island Bureau of Hospitals has used large quantities of standard weight black wrought iron pipe for steam and condensate lines in concrete ducts. Fig. 52, shows (L. to R.), a medium pressure steam line, a high pressure steam line and a condensate line, being installed in a concrete duct at the State Infirmary, Wallum Lake, Rhode Island. All three lines are welded, and were insulated before the duct was covered and the earth replaced.

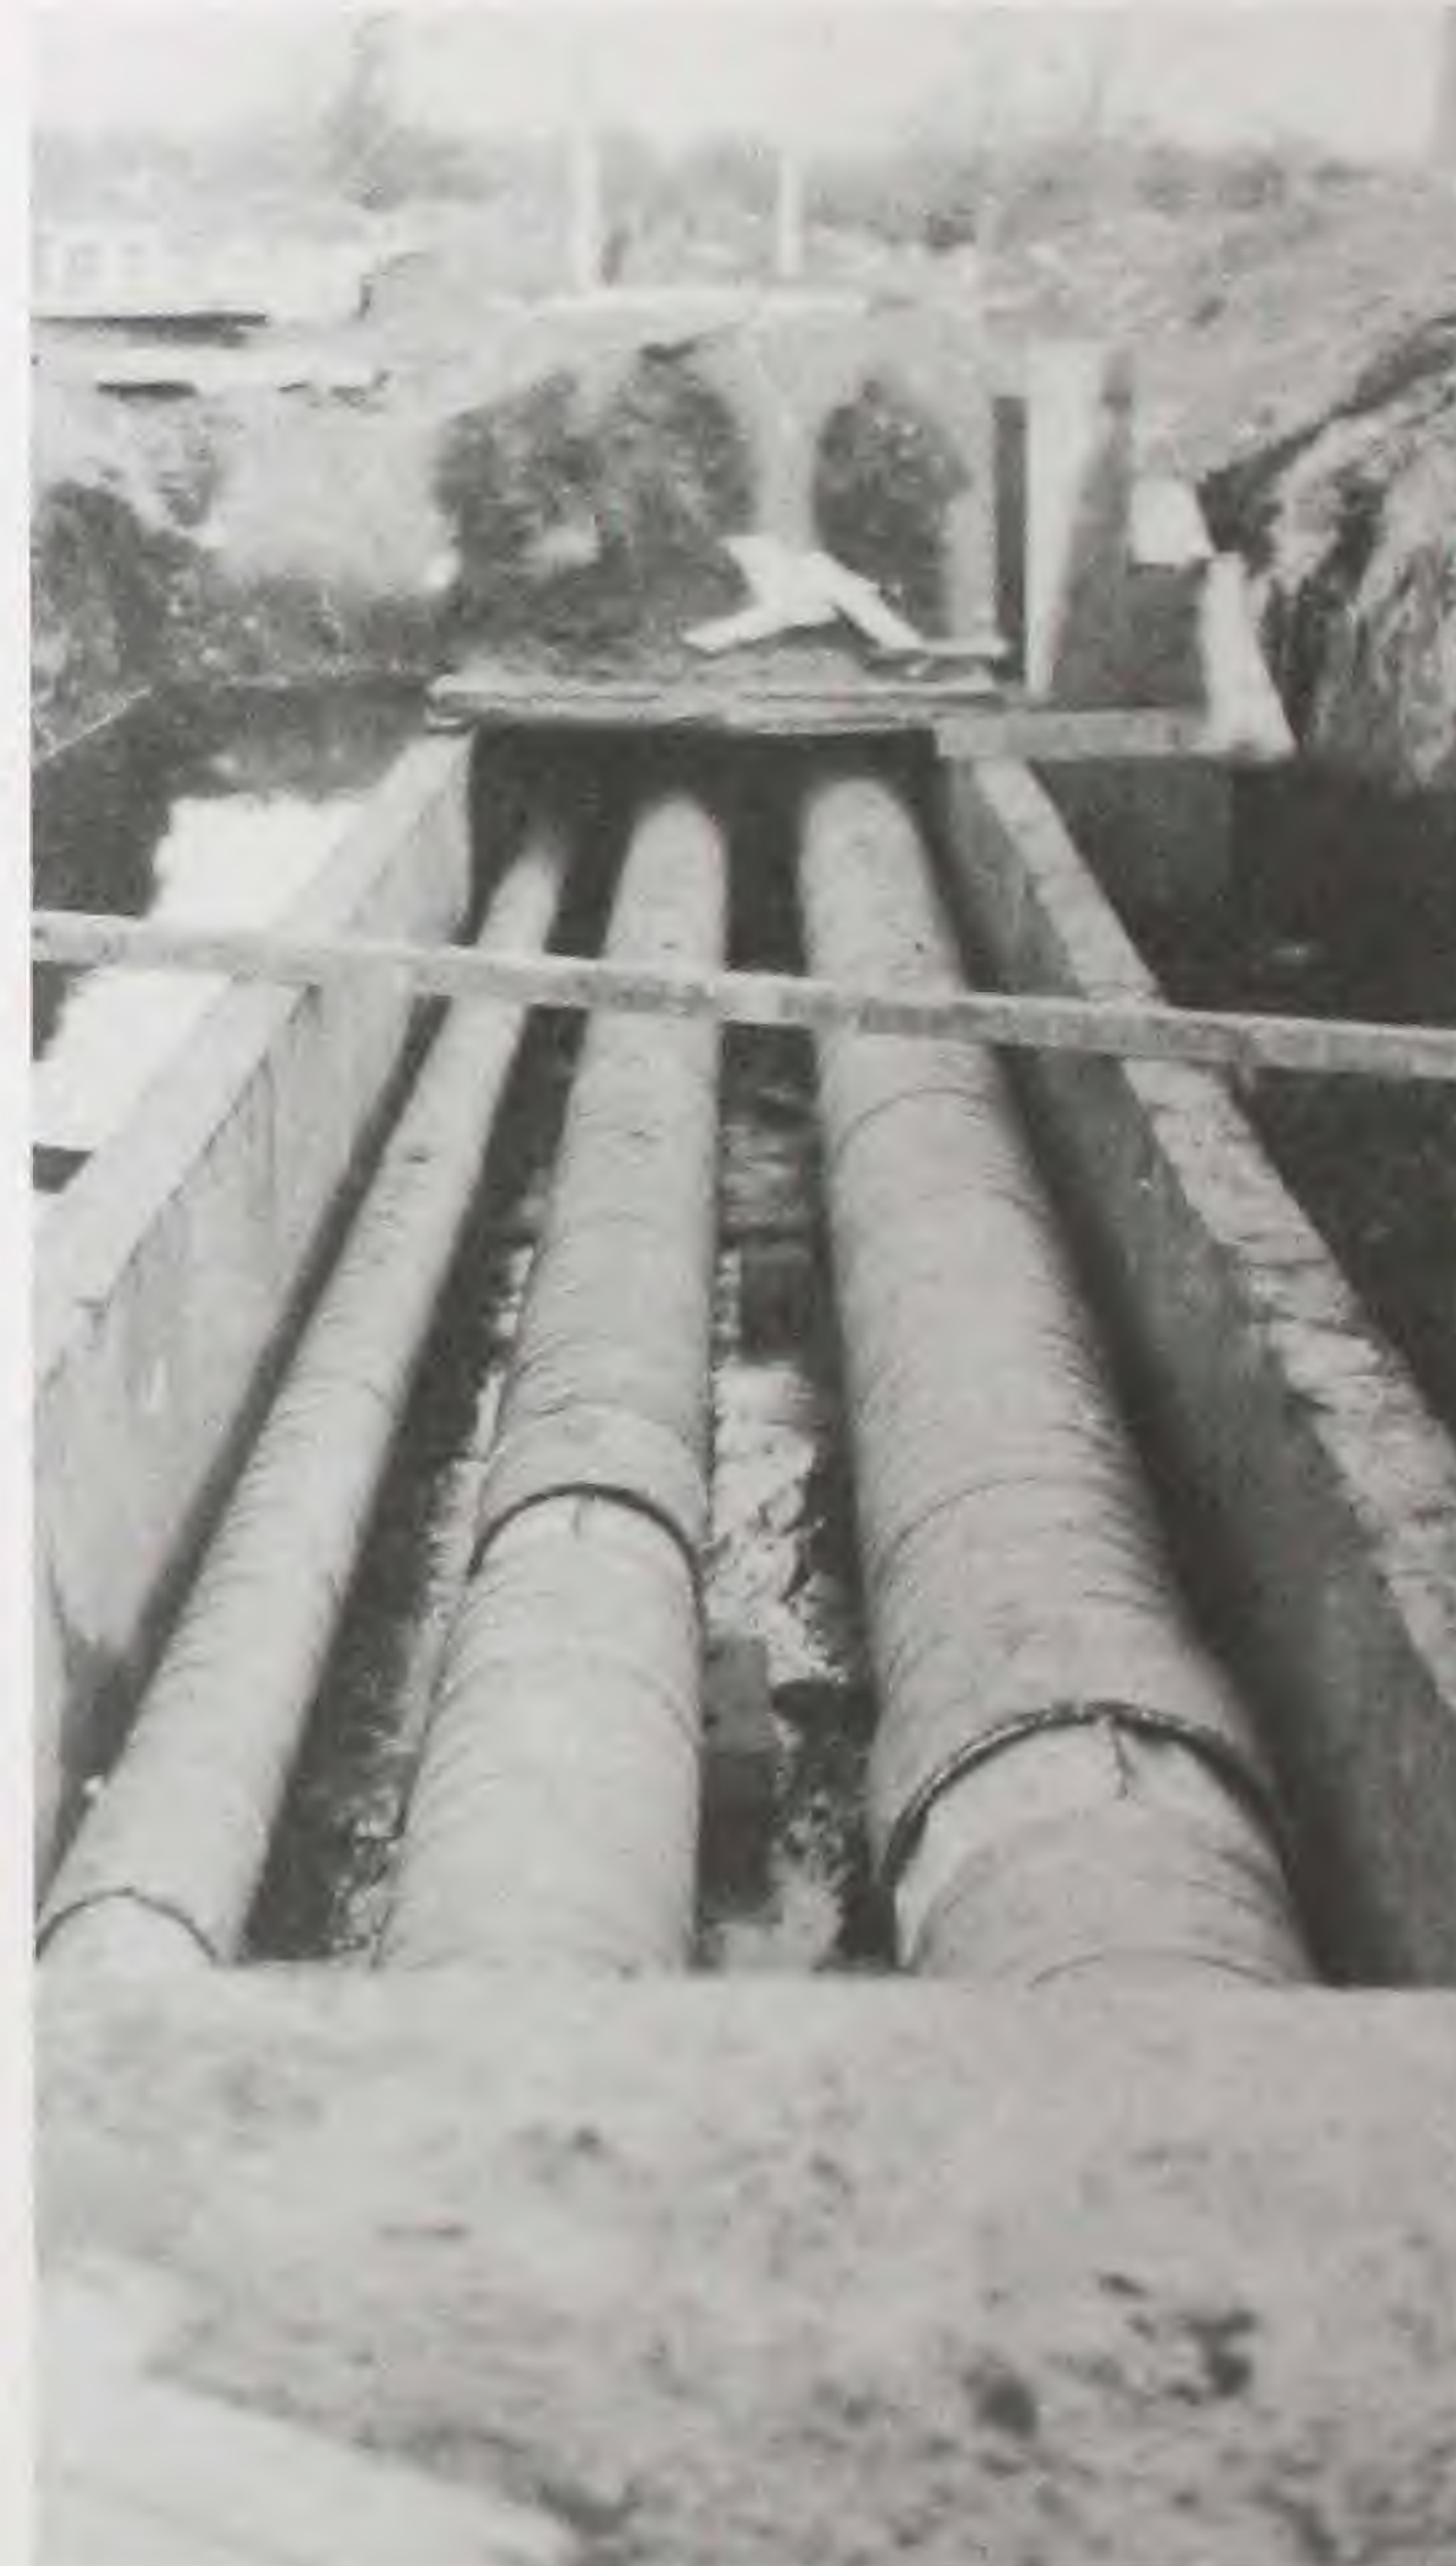
Fig. 53

Nearly 200 tons of wrought iron pipe were used in a similar installation at the Rhode Island State Hospital and Infirmary at Howard, Rhode Island. This insulated pipe is shown in Fig. 53.

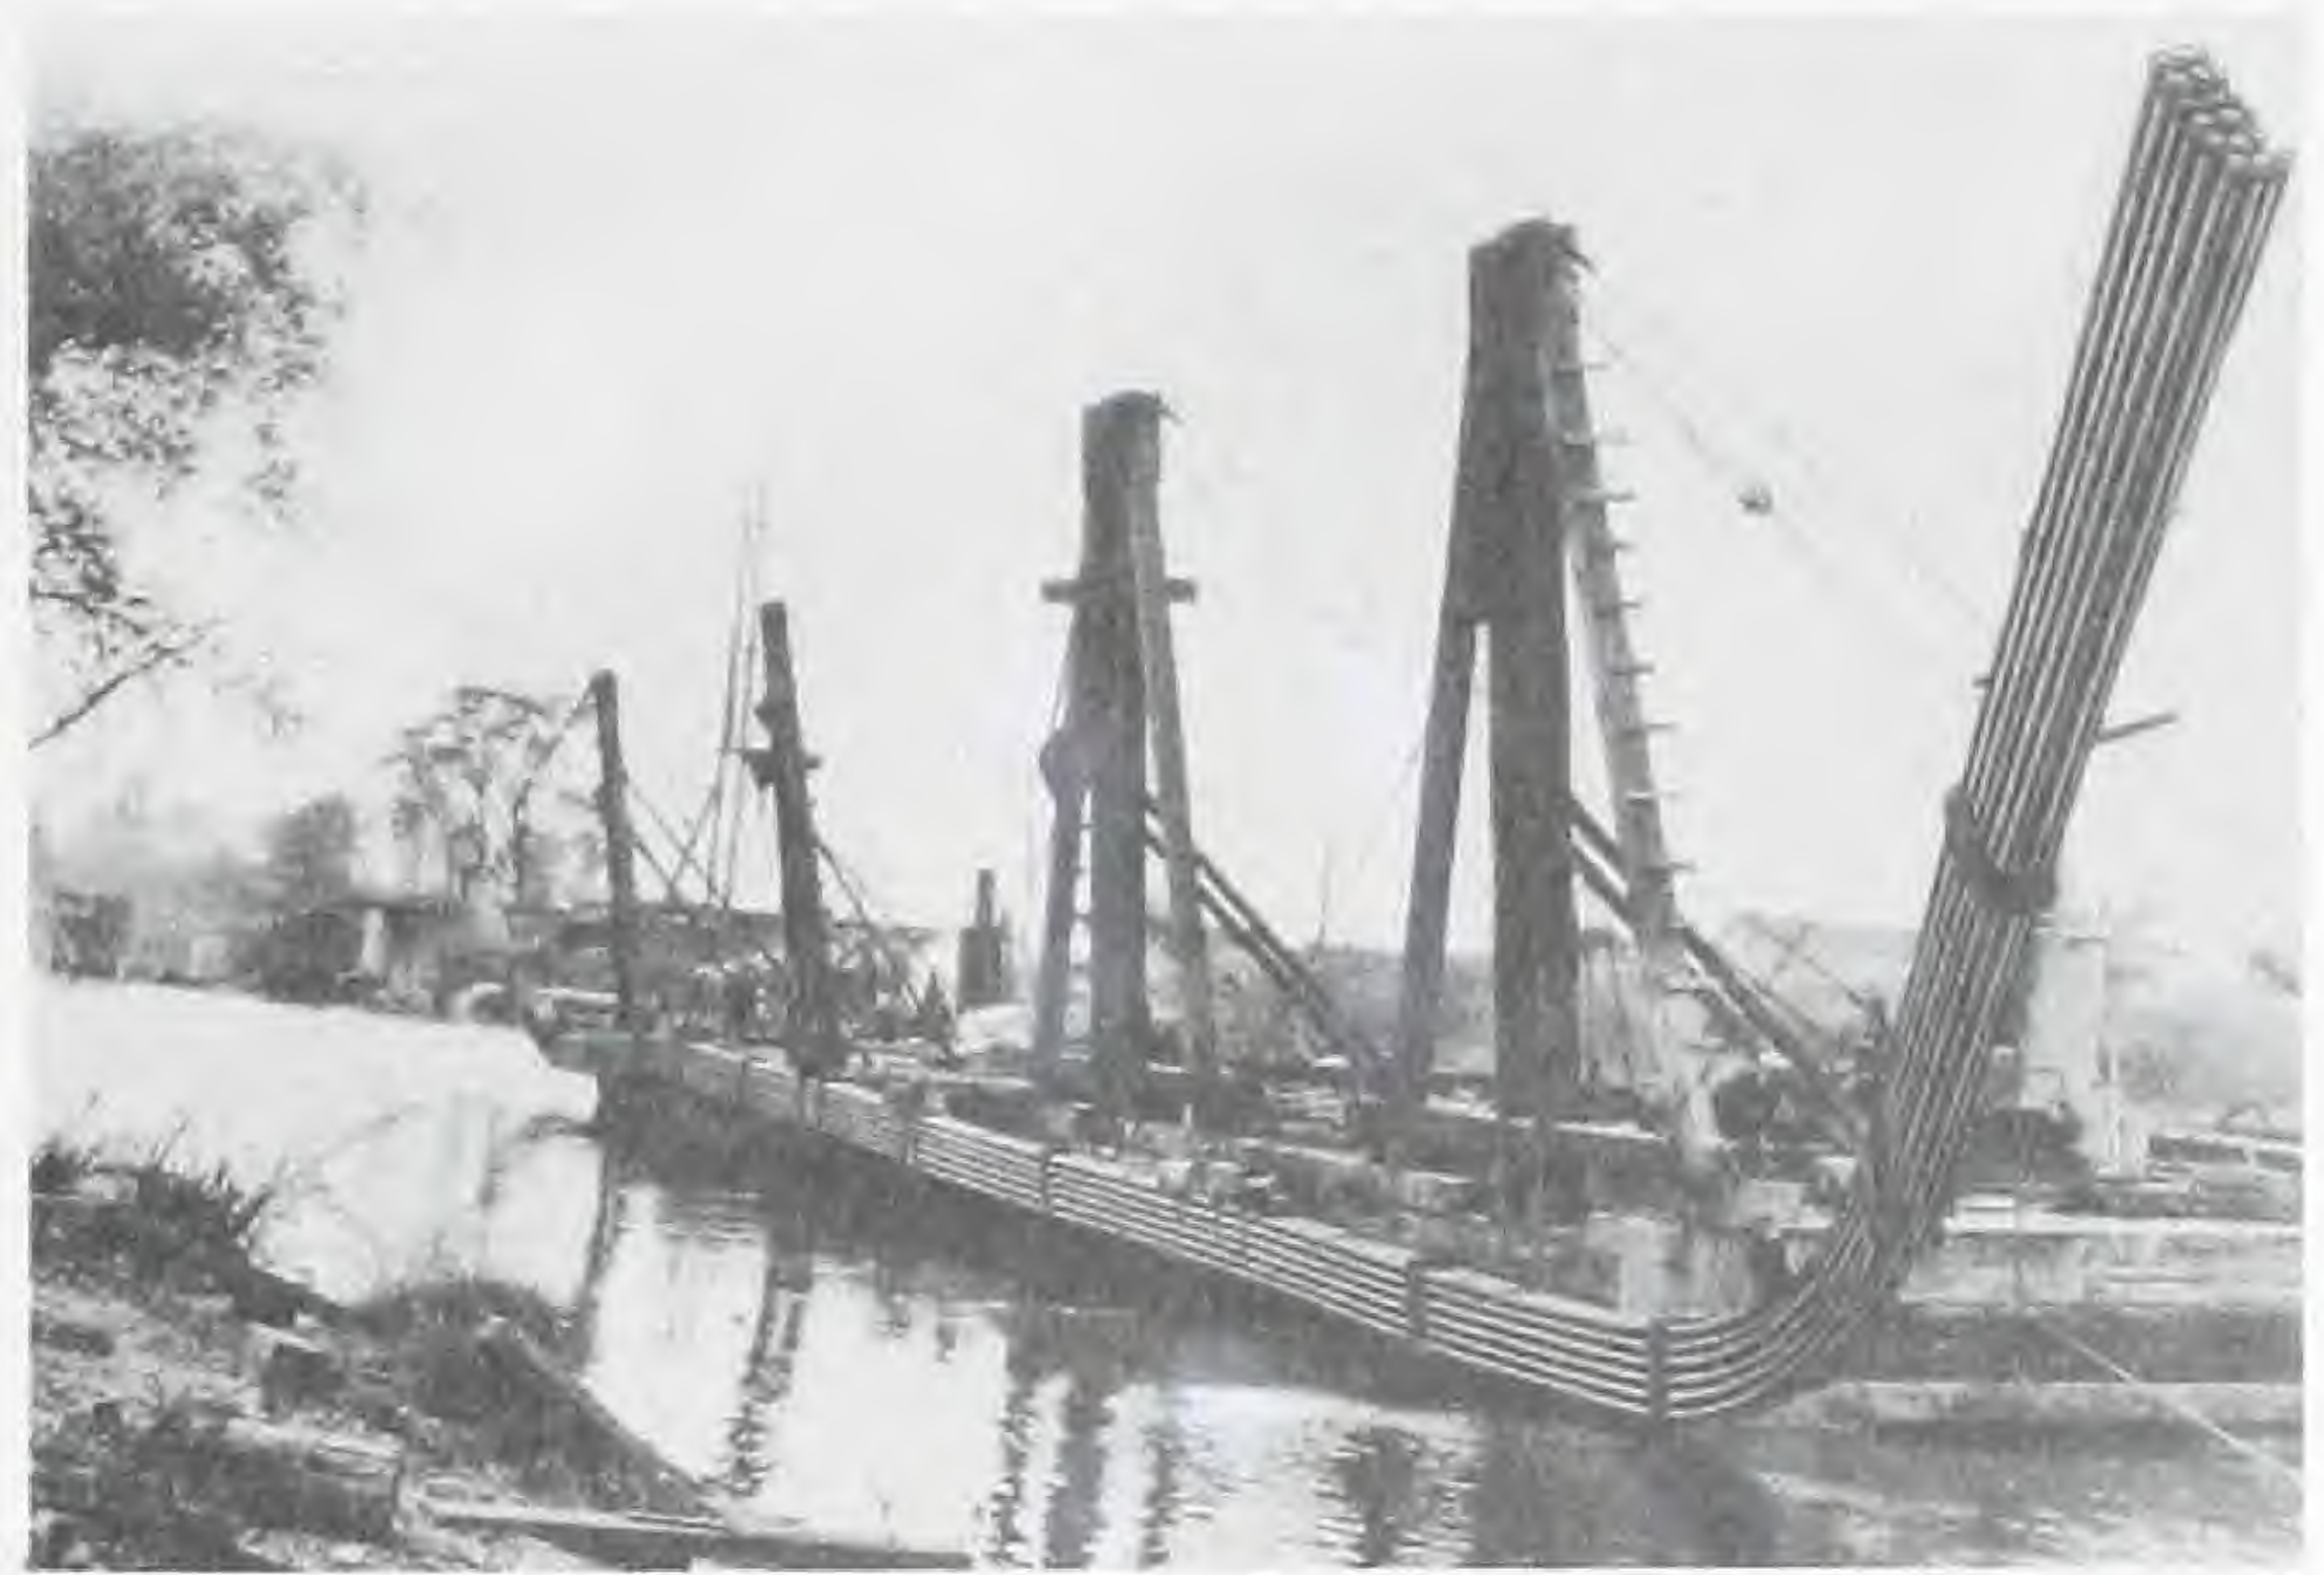
The cable conduit shown in Fig. 54 was installed to carry the cables of the American Telephone and Telegraph Company and the Illinois Bell Telephone Company under the Calumet River, near Chicago. Over three miles of 3½" black genuine wrought iron pipe were required, and the lengths were joined with threaded couplings. Fillet welds were then made at each end of each coupling to reinforce the joints and provide a perfectly tight seal. After being lowered into place, the lines were filled with a light mineral oil which prevents condensation and serves to indicate that there are no leaks. The conduit has been in service over 13 years, and a recent inspection revealed that it is still functioning perfectly and that no loss of oil has occurred.

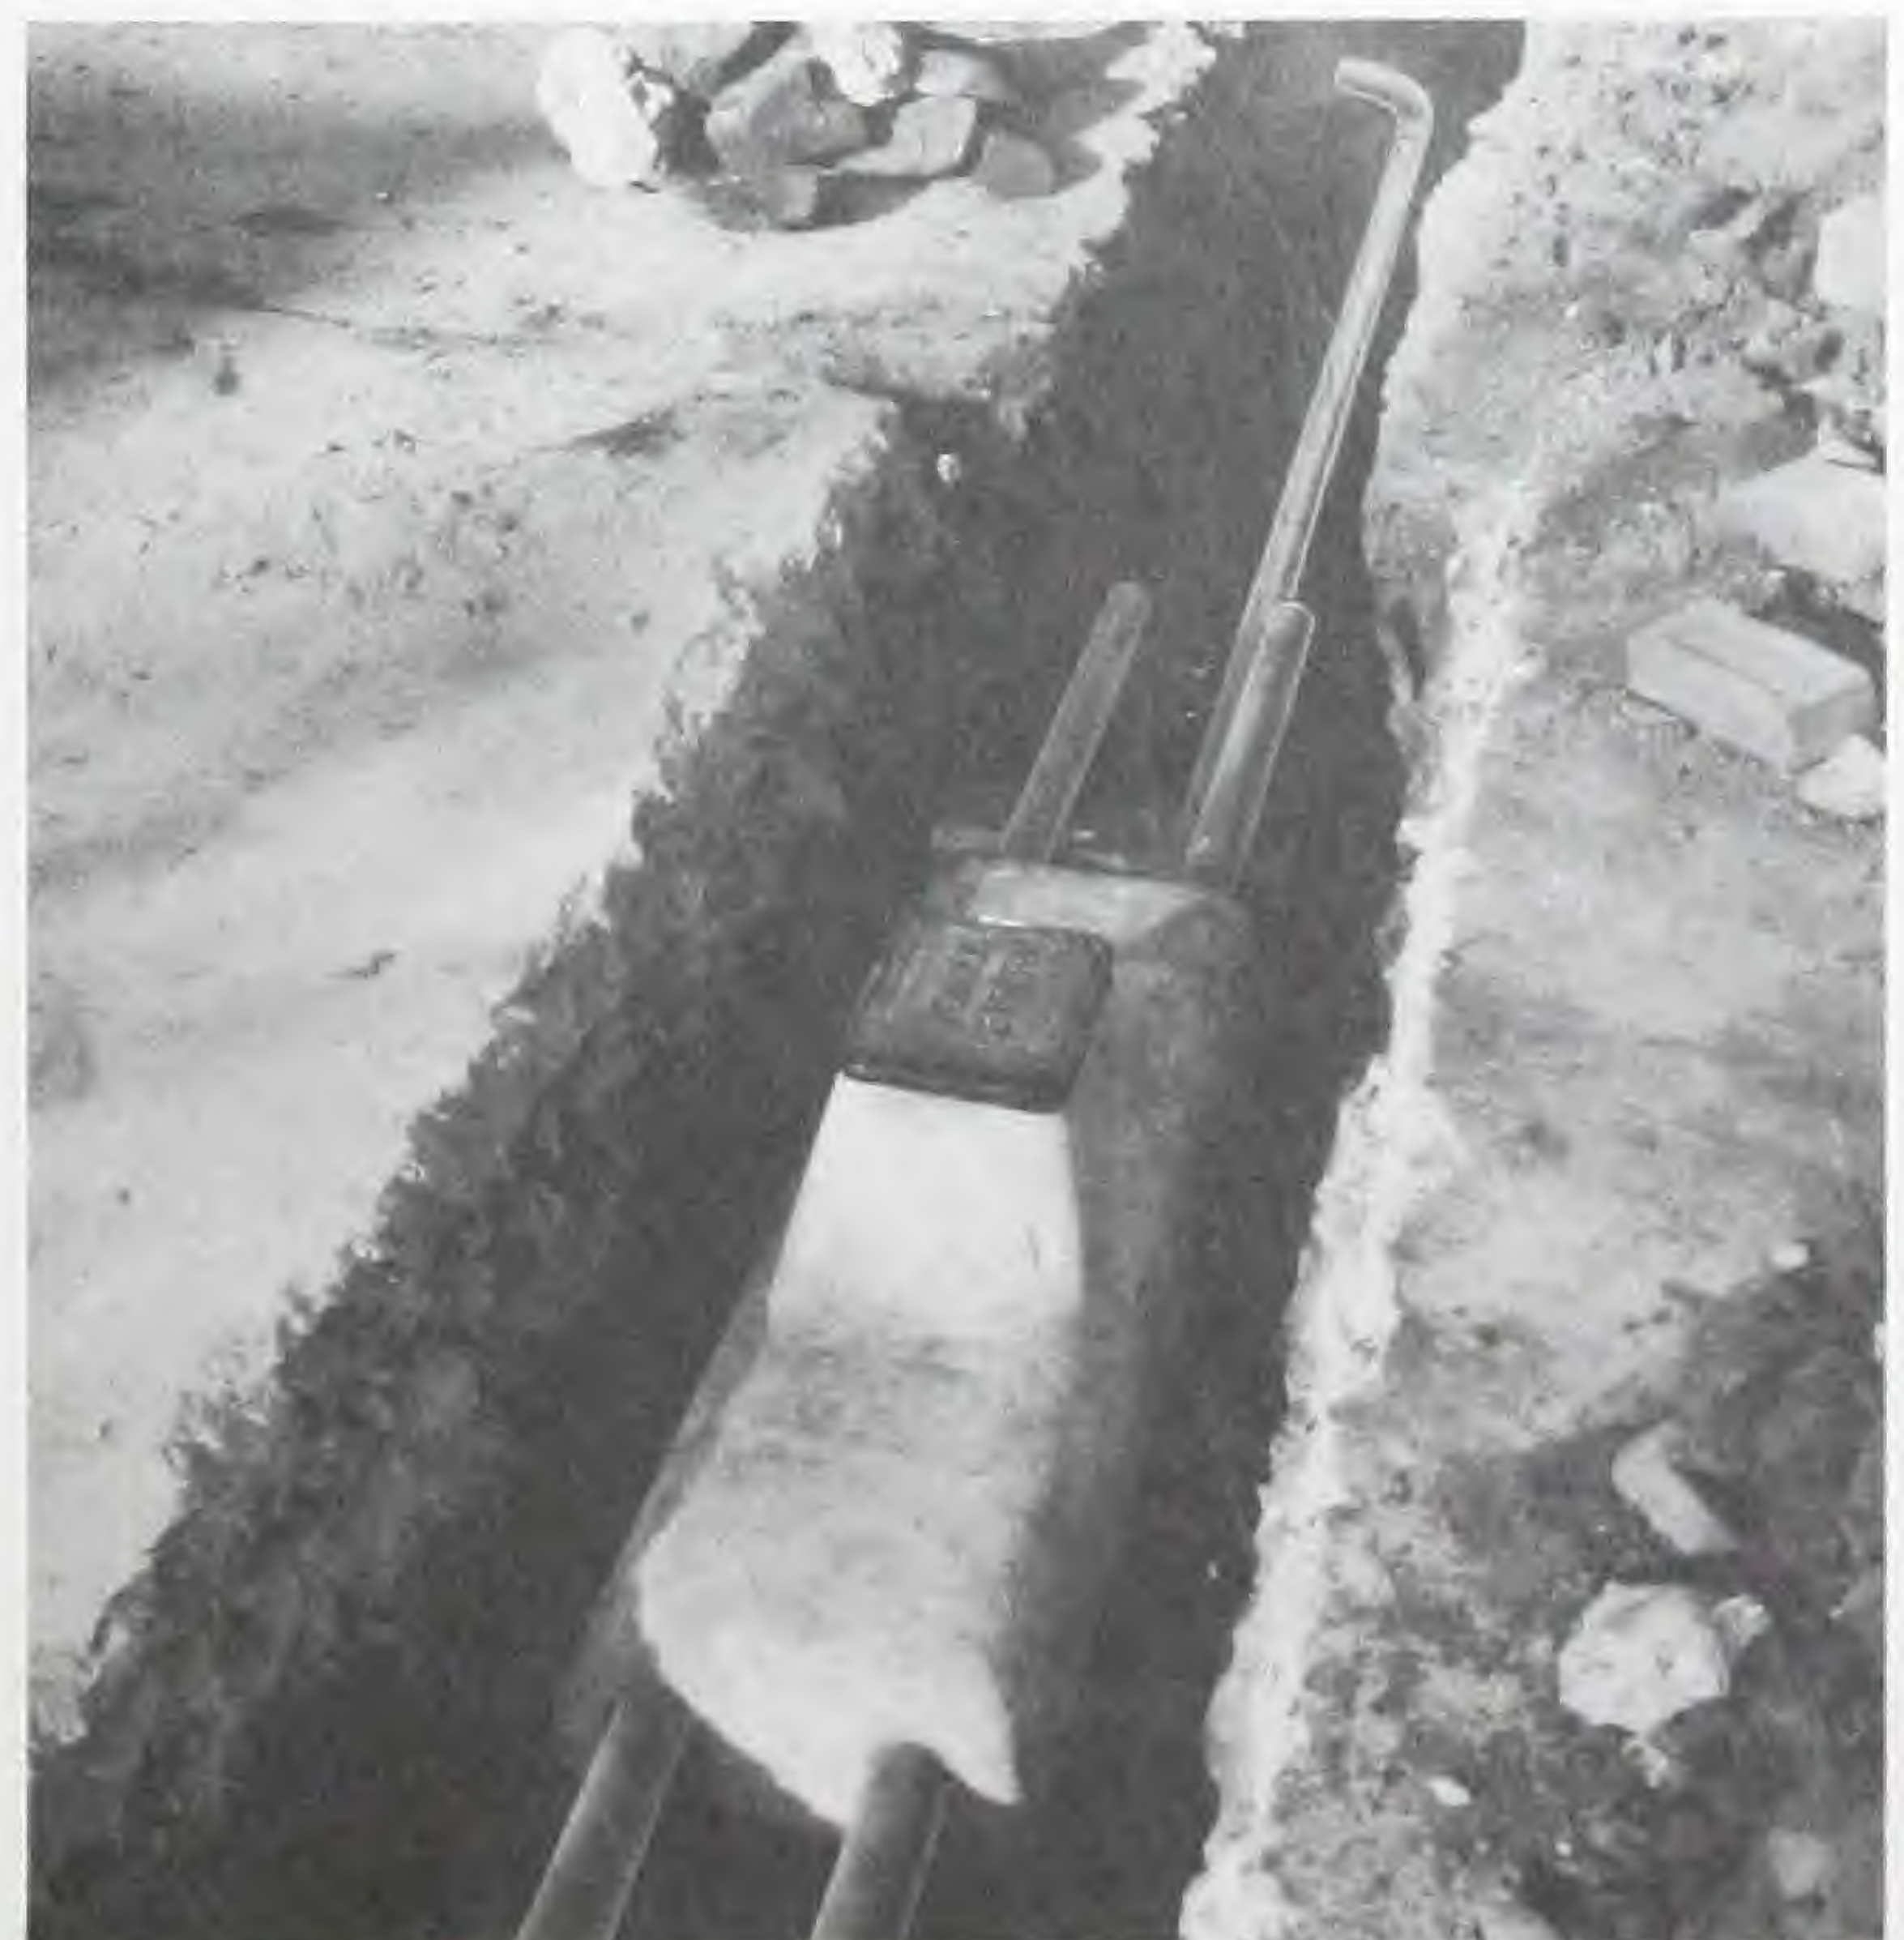
devices are actuated by the magnetic effect produced as a vehicle moves over them, and they are used to change signal lights where it is necessary to admit cars to main highways from side roads. When the car passes over the detector, the signal light changes, stopping traffic on the main artery for 20 seconds. Fig. 55 shows a unit being installed, and the conduit leading to the signal can be seen in the background.

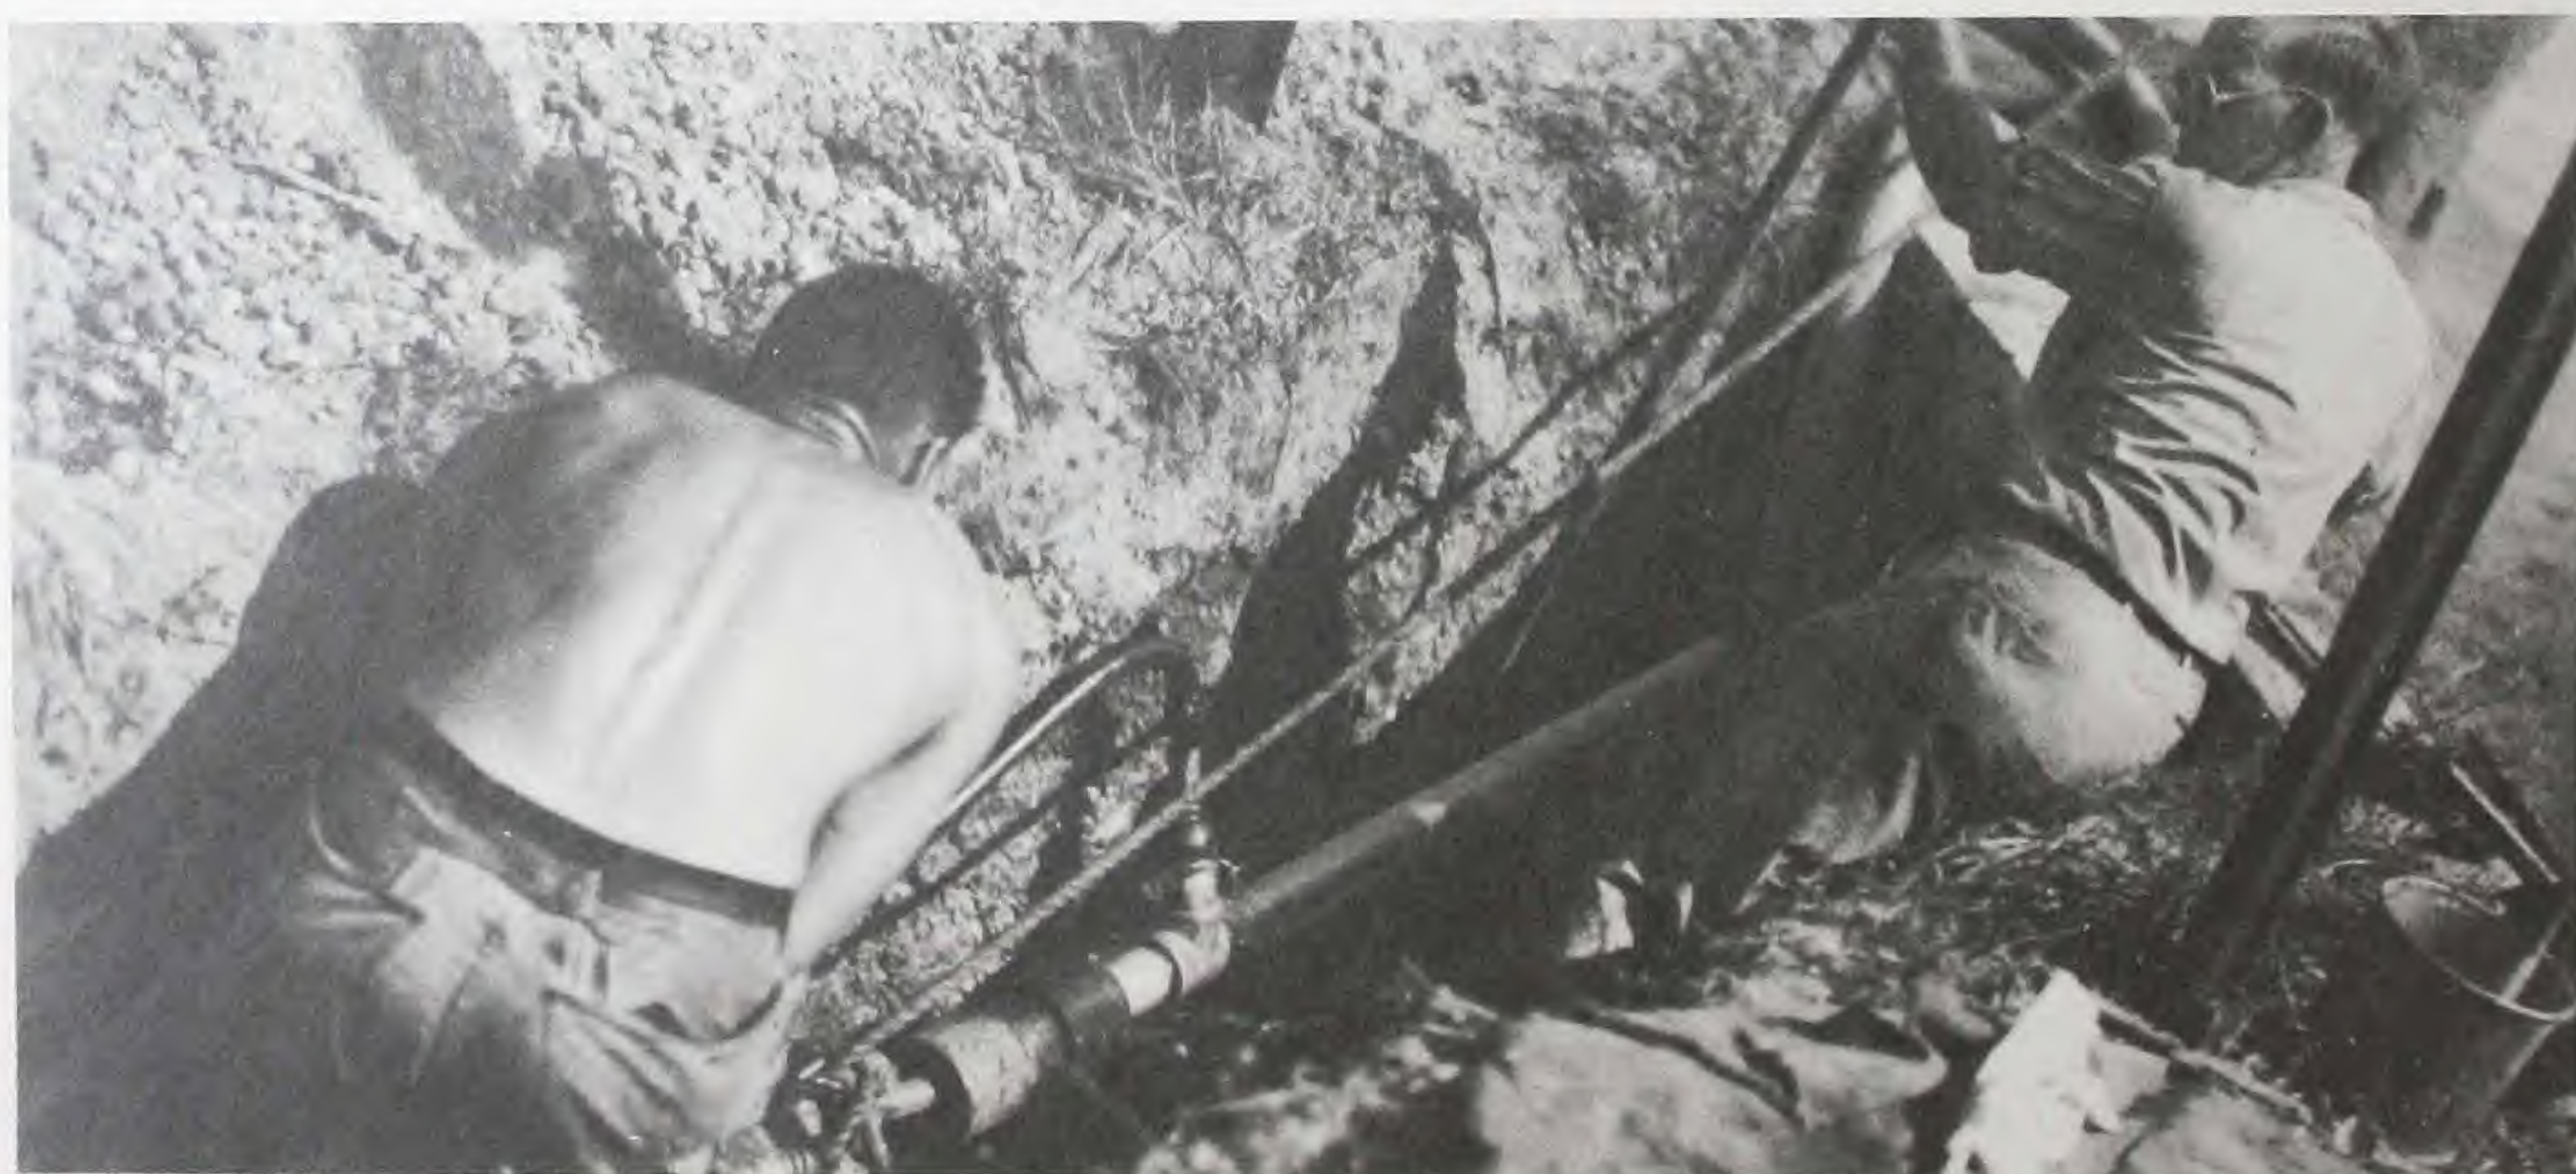
Wrought iron pipe has the rigidity and toughness necessary to permit it to be jacked or driven through the hard-packed soil under roadways. The New Jersey State Highway Department has a standard specification calling for wrought iron for underground cable conduit, and Fig. 56 shows a typical installation being made. Only a short trench was dug at each end of the run of conduit. The intervening section was driven through from one end, using an air hammer.

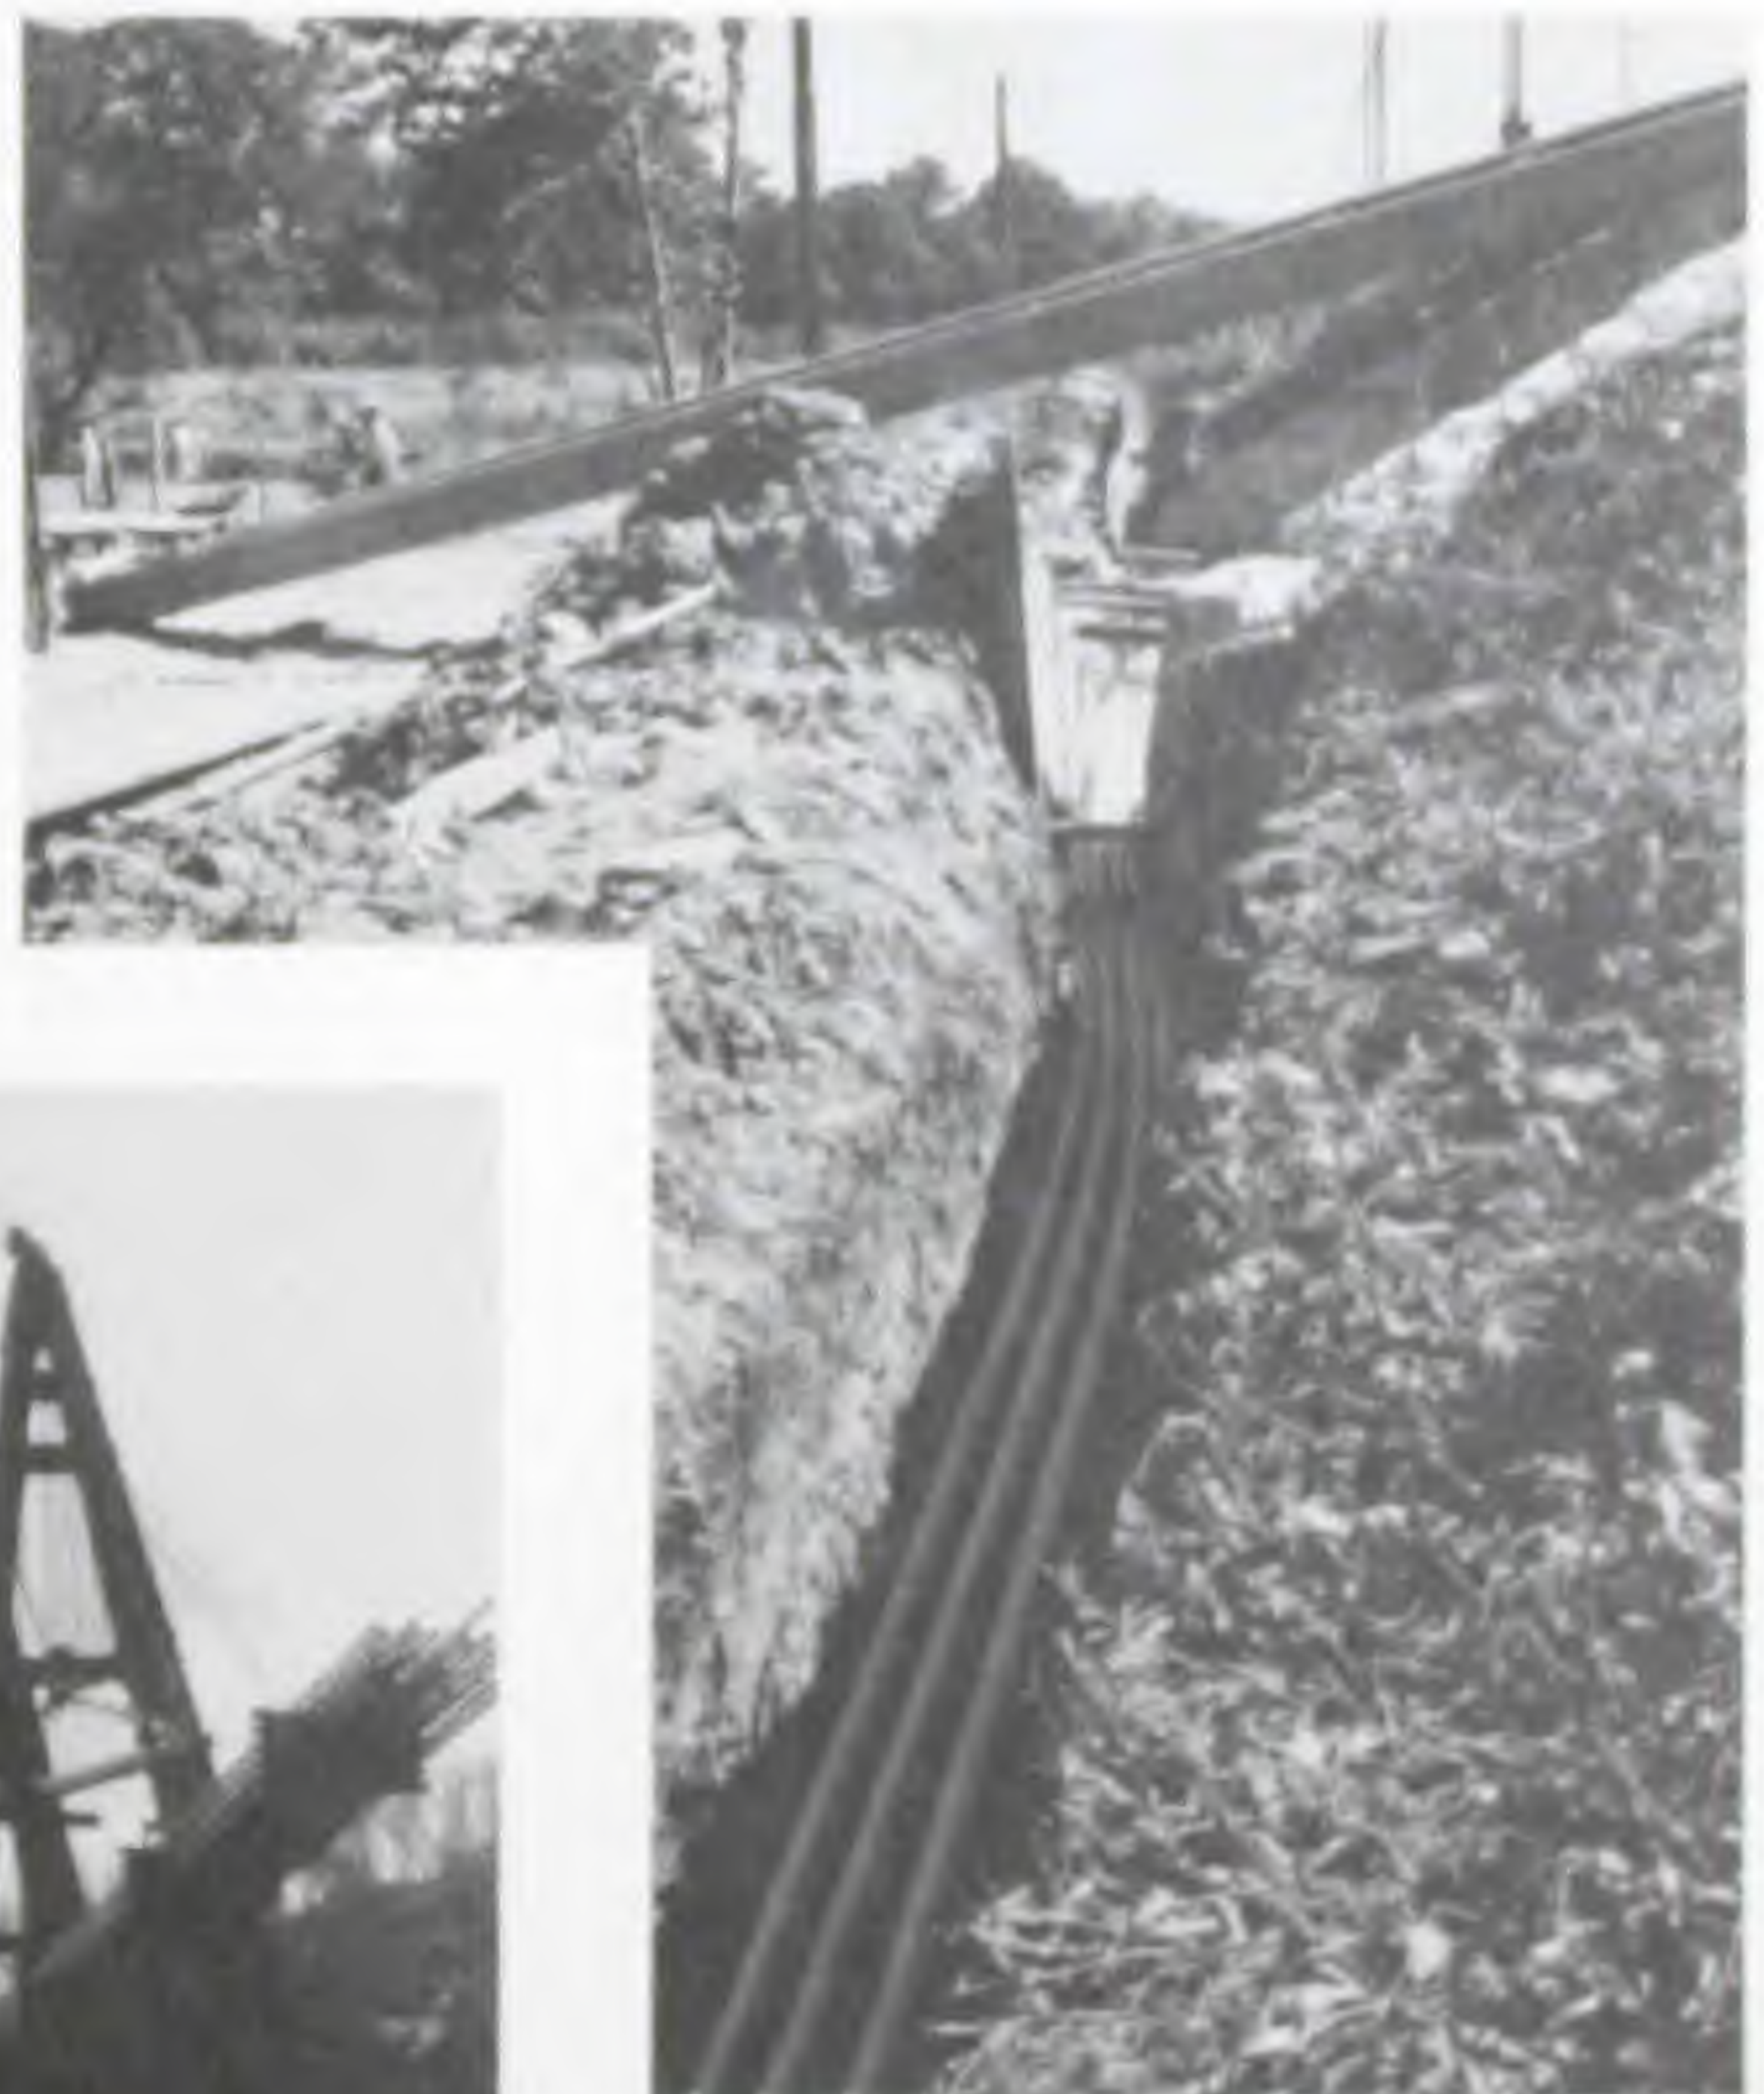
Signal cables paralleling the Pennsylvania Railroad Electrification near Newark, Delaware, are protected by wrought iron conduit where they pass under Christiana Creek. Floods had caused trouble before, so a trench was dug in the creek bed, four lines of 3" extra strong conduit were laid, and cement was poured over the lines. Fig. 60 shows this crossing being installed.
